Investigation of the Performance of the New Orleans Flood Protection Systems in Hurricane Katrina on August 29, 2005

Volume I: Main Text and Executive Summary

**Final Report
July 31, 2006**

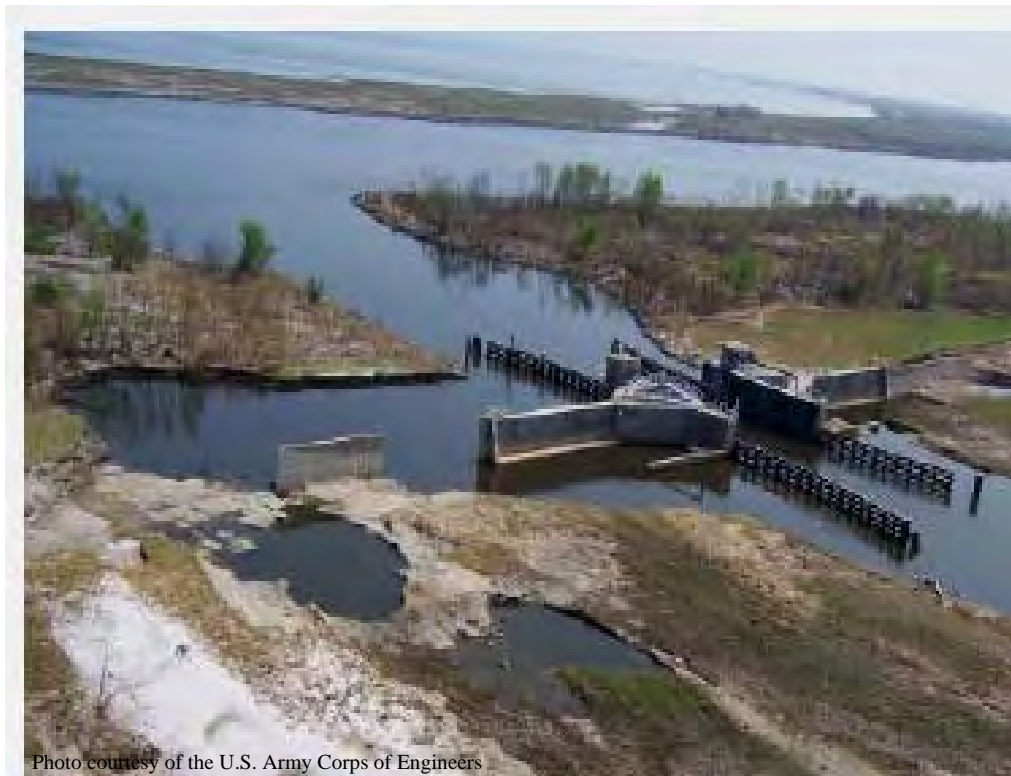
Figure 6.9(a) is an oblique aerial of the smaller Bayou Dupres concrete navigation structure situated farther to the south along this same MRGO levee frontage, showing a similar massive eroded breach at the juncture between the northwest end of the concrete structure and the adjoining earthen levee section. Figure 6.9(b) shows a second view, taken from the eroded breach and looking to the inboard (protected) side along the north flank of Bayou Dupres, showing the eroded detritus strewn inland from this breach. In this figure, it can be clearly seen that large fractions of the eroded material consisted of shell sand fill. The use of lightweight shell sand fill had been called for at this interface section in order to

Figure 6.9(a): Aerial view of the large erosional breach at the contact between the north end of the concrete navigational lock structure and the adjoining levee embankment at Bayou Dupres.

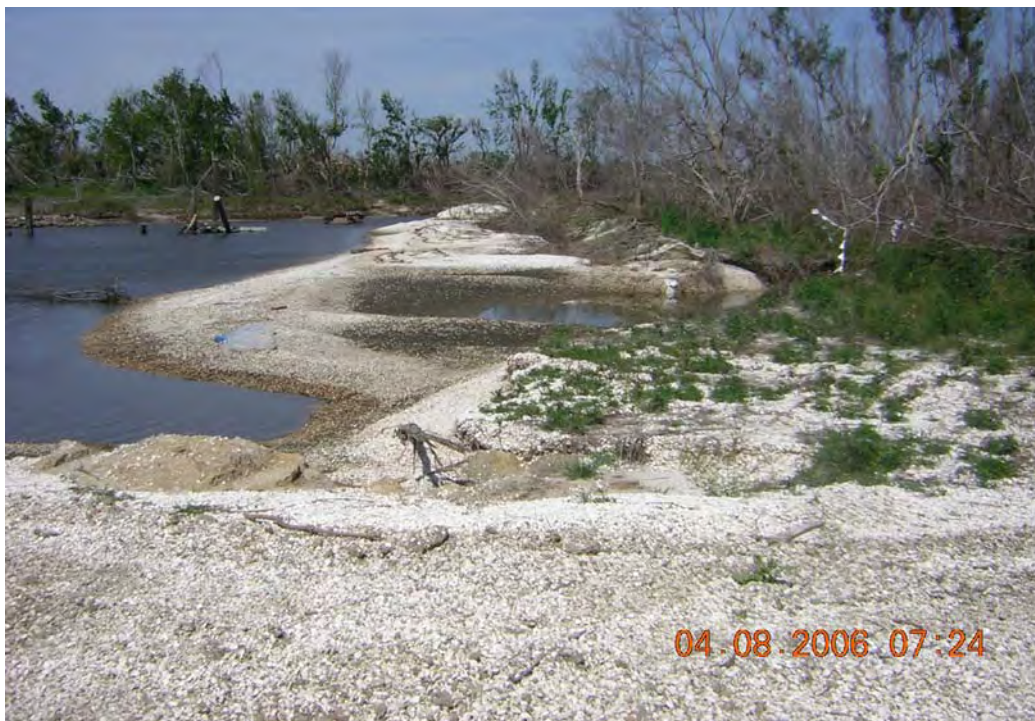
Figure 6.9(b): View looking to the inboard side from the breach shown in Figure 6.5 above; showing eroded shell sand detritus deposited from the breach.

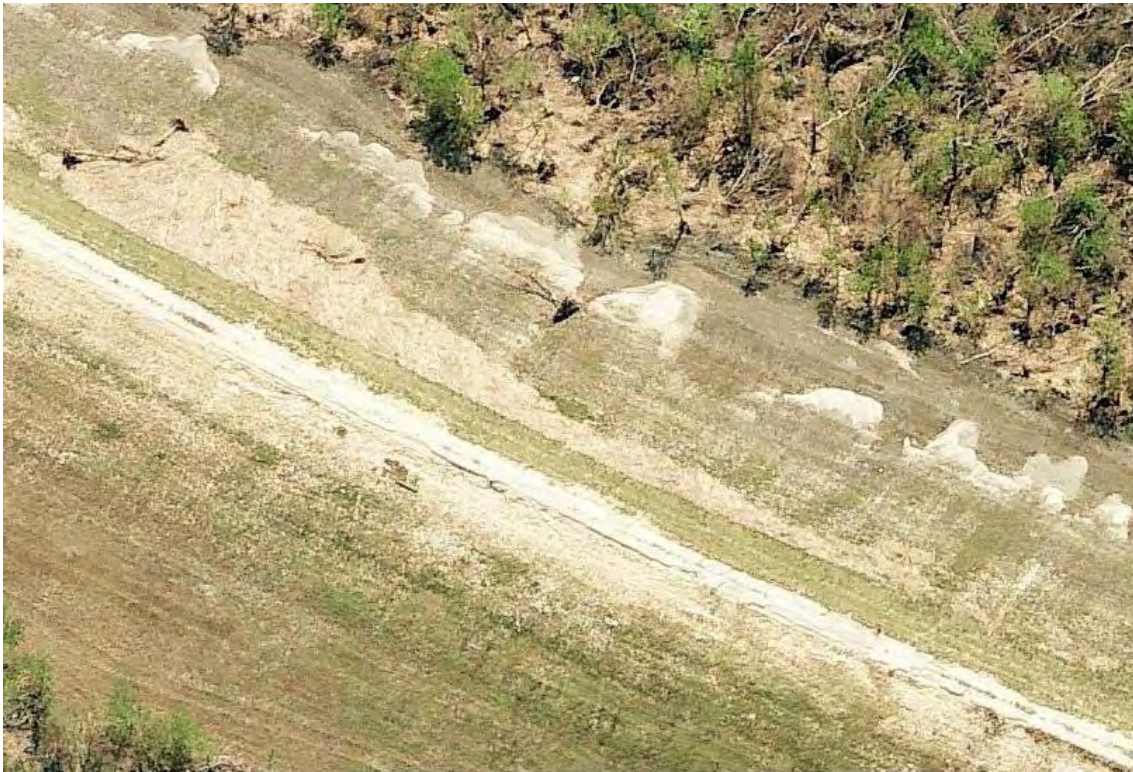
Figure 6.11(b) illustrates two additional potential sets of erosion modes likely to have been active along sections of the MRGO frontage levees. One is the attacking of the outboard side (water side) face of the levee by storm waves. These high energy waves can scallop and erode the outboard face. They can also rush up the face toward the crest, and can erode “notches” in the crest from the front side. Subsequent waves can then pass through these notches, especially as the storm surge continues to rise, and the flow can widen the notches and also erode the back face levee slope (as discussed above as “sheet flow overtopping erosion”.) This exploitation and widening of crest notches is called crenellation, after the crenellation (notched shape) that often tops castle walls.

Figure 6.12: Photo of outboard side wave-induced erosion on the MRGO levee frontage at the northeast edge of the St. Bernard/Ninth Ward protected area.

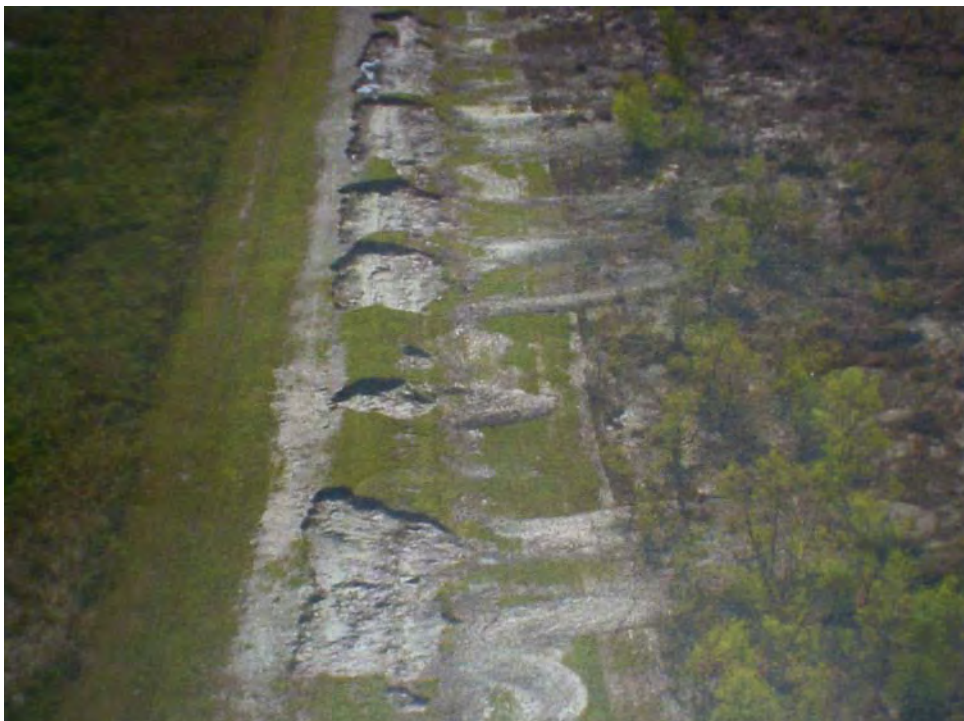
Figure 6.13: Photo of outboard side levee erosion and crest “notching”, as well as crenellation, due to storm wave erosion and overtopping along the MRGO frontage levees at the northeast edge of the St. Bernard/Ninth Ward protected area.

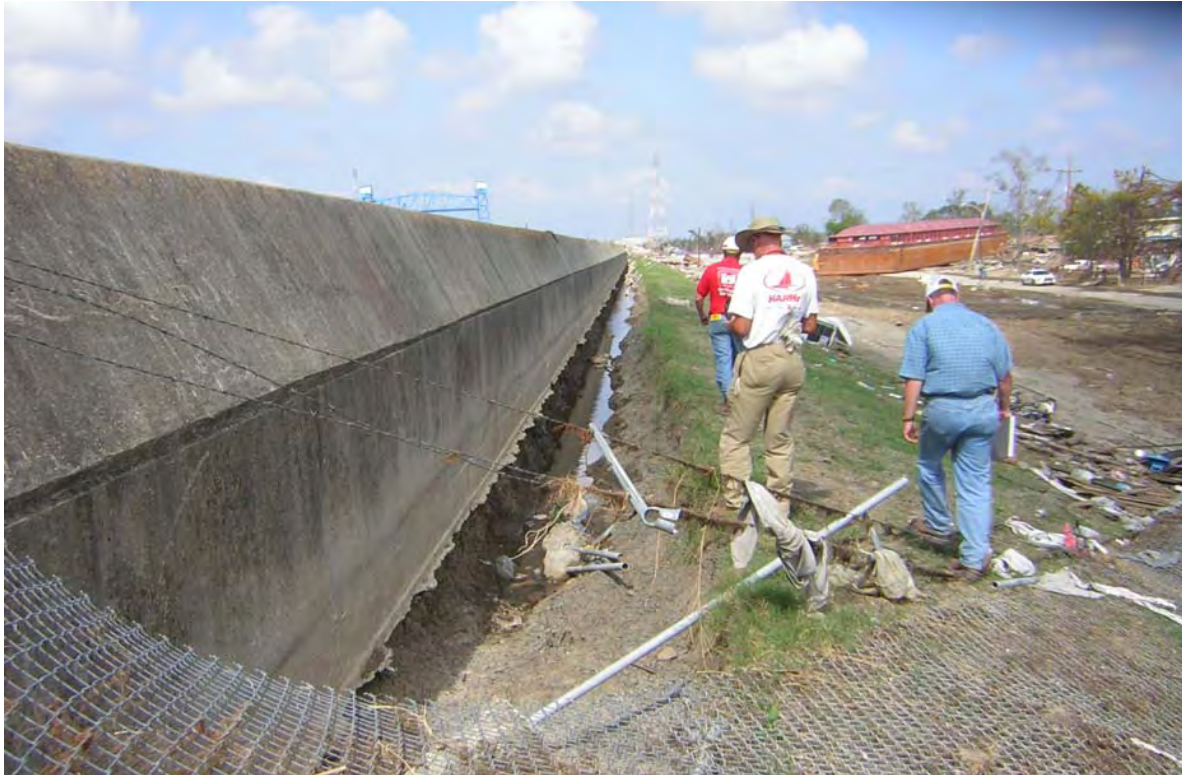
Figure 6.22: Eroded trench at the rear (inboard) side of the floodwall at the south end of the south breach at the east bank of the IHNC at the west end of the Lower Ninth Ward.

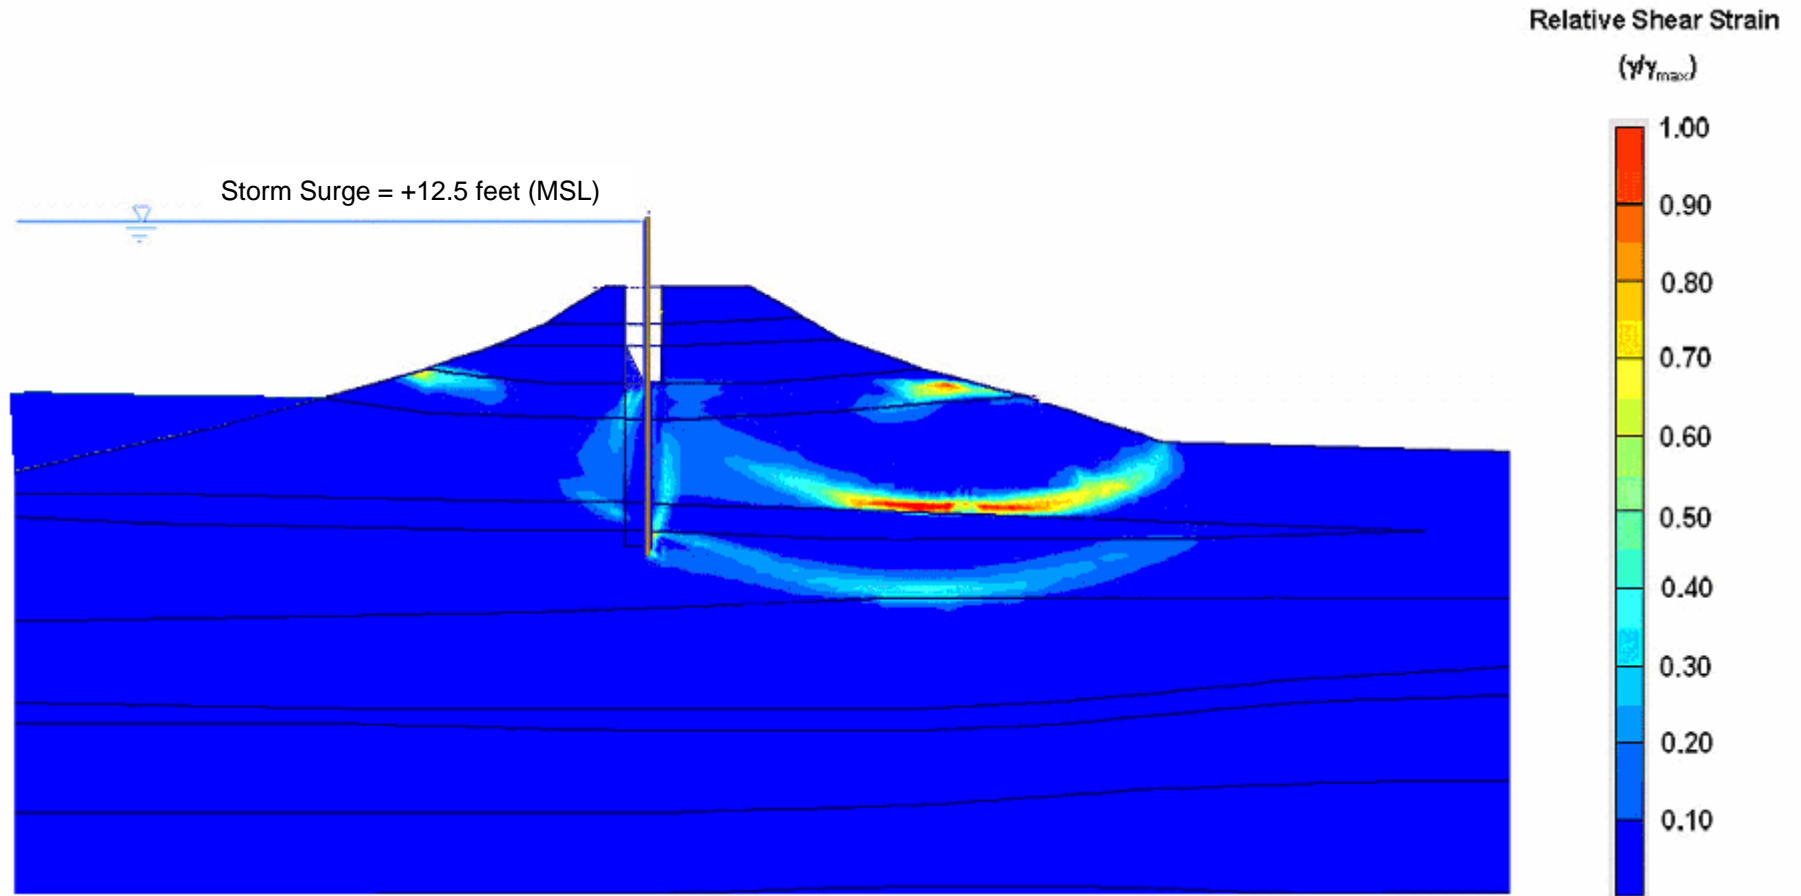
Figure 6.31: Normalized shear strain contours (shear strain divided by strain to failure) for a storm surge at Elev. + 14 feet (MSL) at the Lower Ninth Ward, IHNC East Bank, South breach site; gapping at outboard toe of floodwall is fully developed.

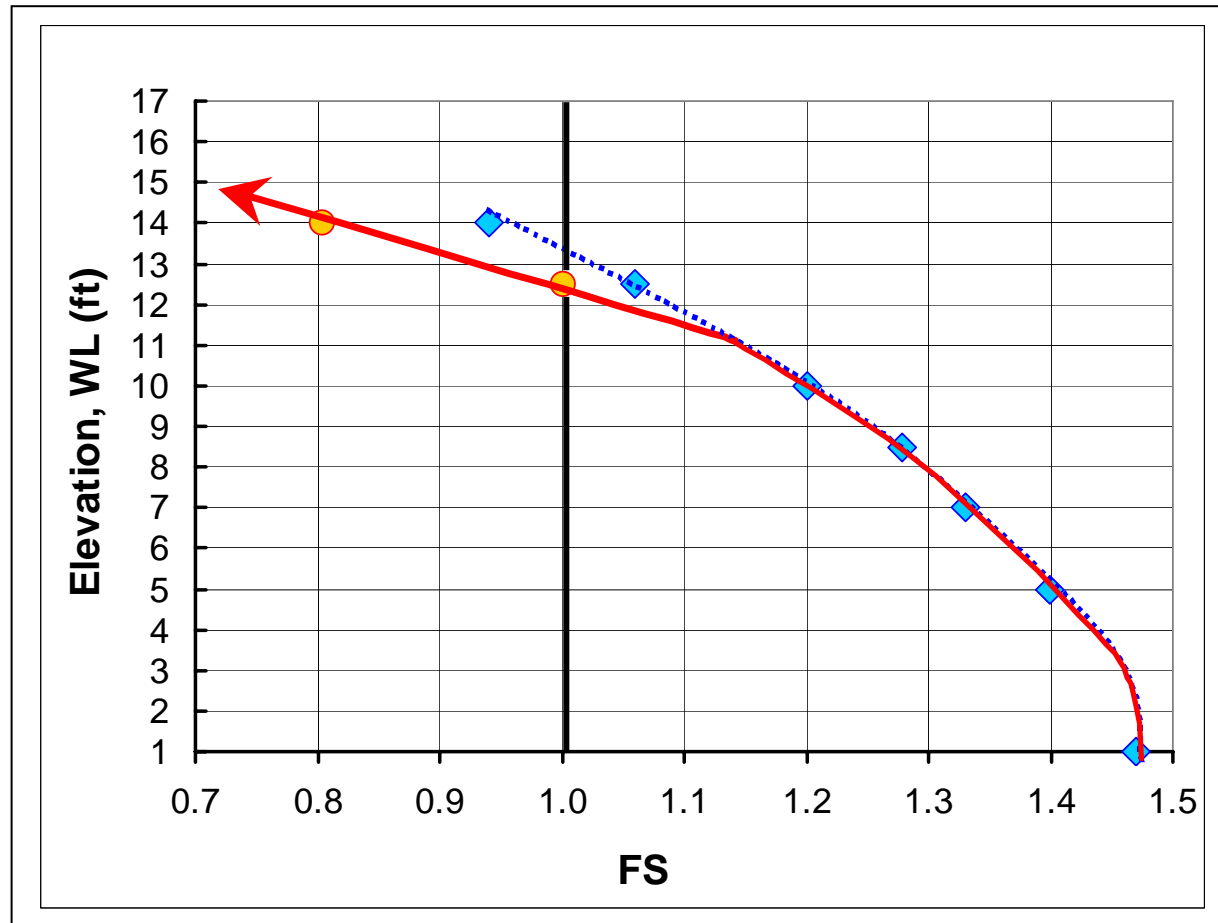
Figure 6.32: Calculated Factors of Safety for two modes based on PLAXIS analyses of the Lower Ninth Ward South breach site (east bank IHNC) for various canal water elevations; showing the best-estimated path to failure.

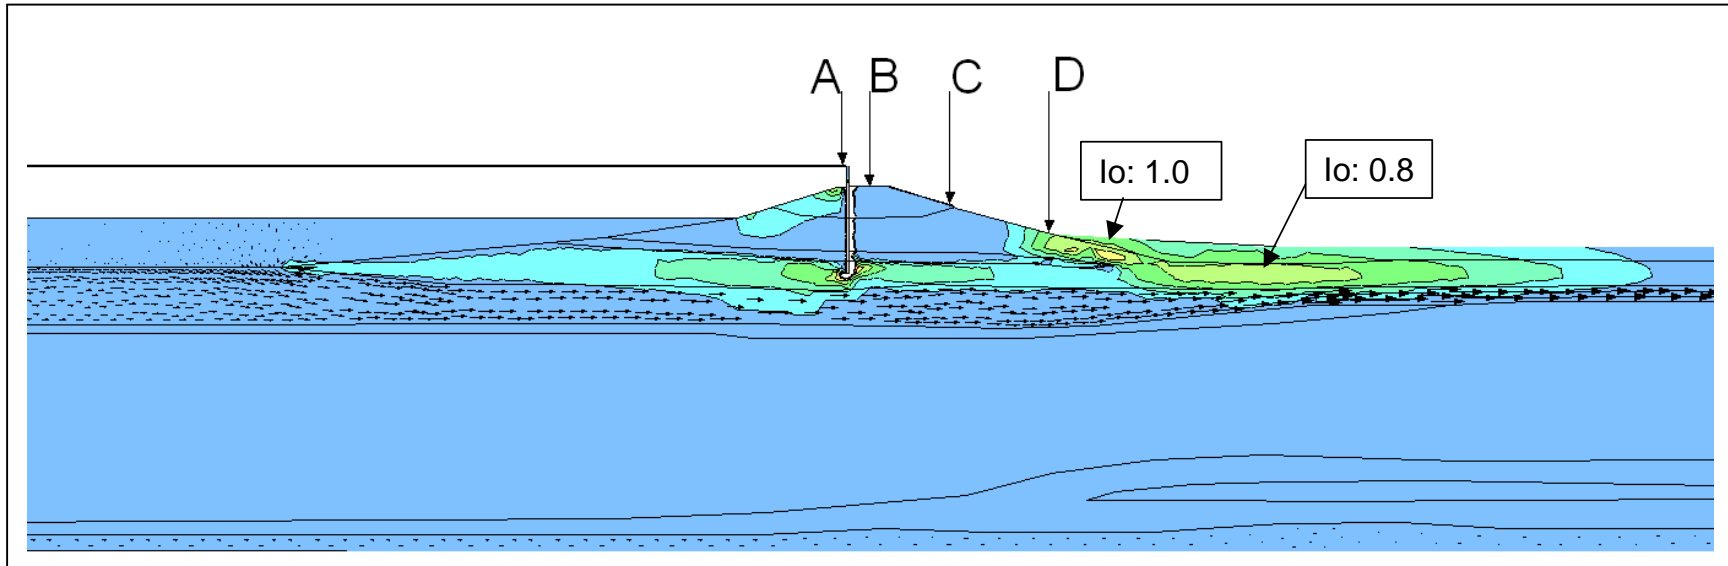
Figure 6.3 7: Hydraulic gradients for the south breach on IHNC east bank; storm surge at 14.4ft (MSL). Maximum exit gradient at the levee toe is $i_o \approx 0.8$ to 1.0.

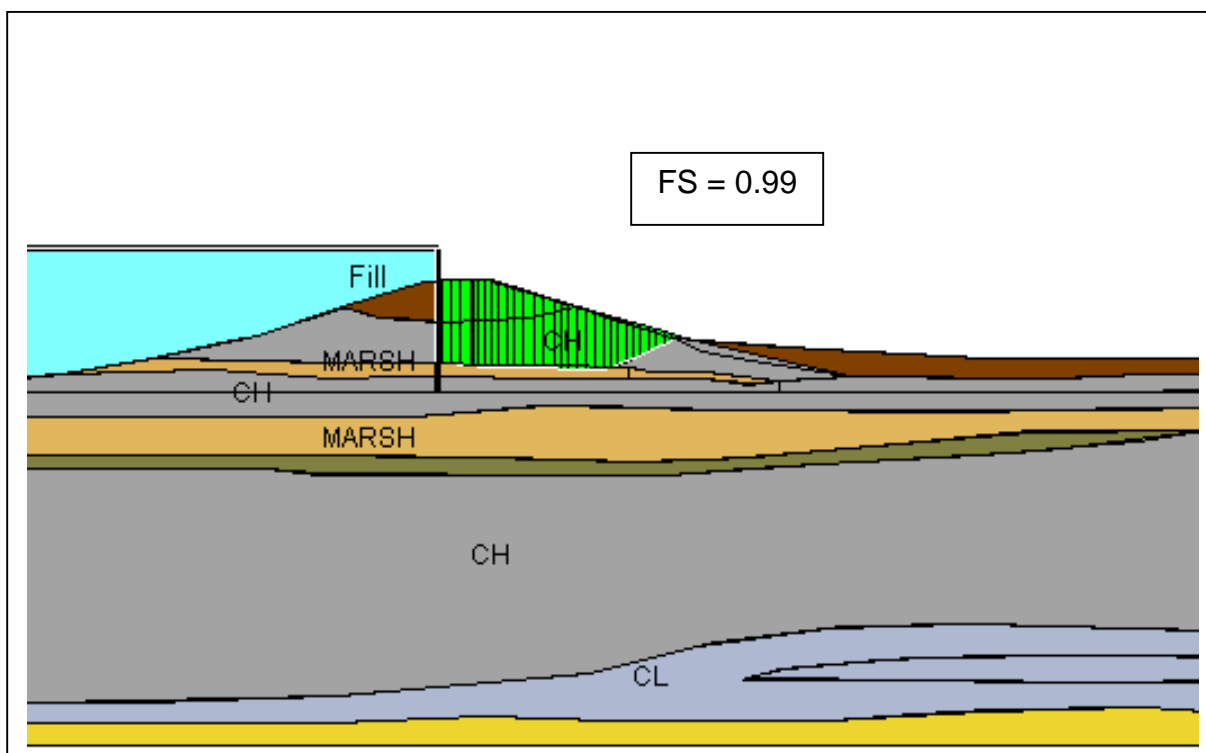
Figure 6.42: Critical failure surface for the south breach on IHNCEast bank; storm surge at 14ft (MSL), failure through upper marsh layer with gap at front of sheetpiles fully developed.

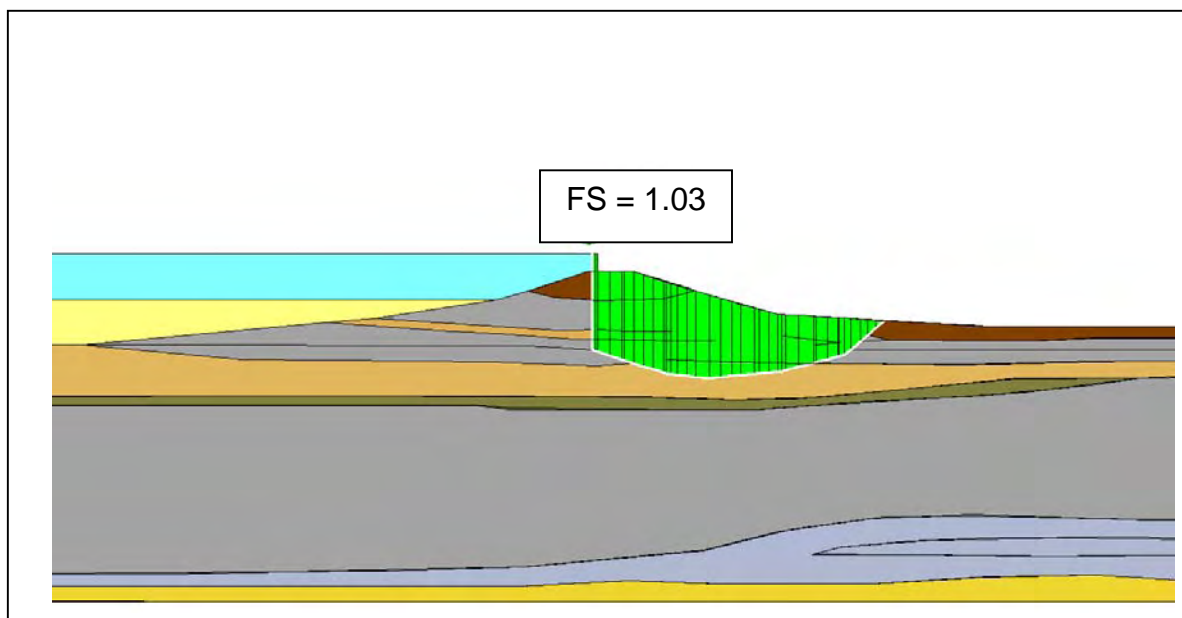
Figure 6.43: Deeper failure surface for the south breach on IHNCEast bank; storm surge at 14ft (MSL), gap at front of sheetpiles fully developed.

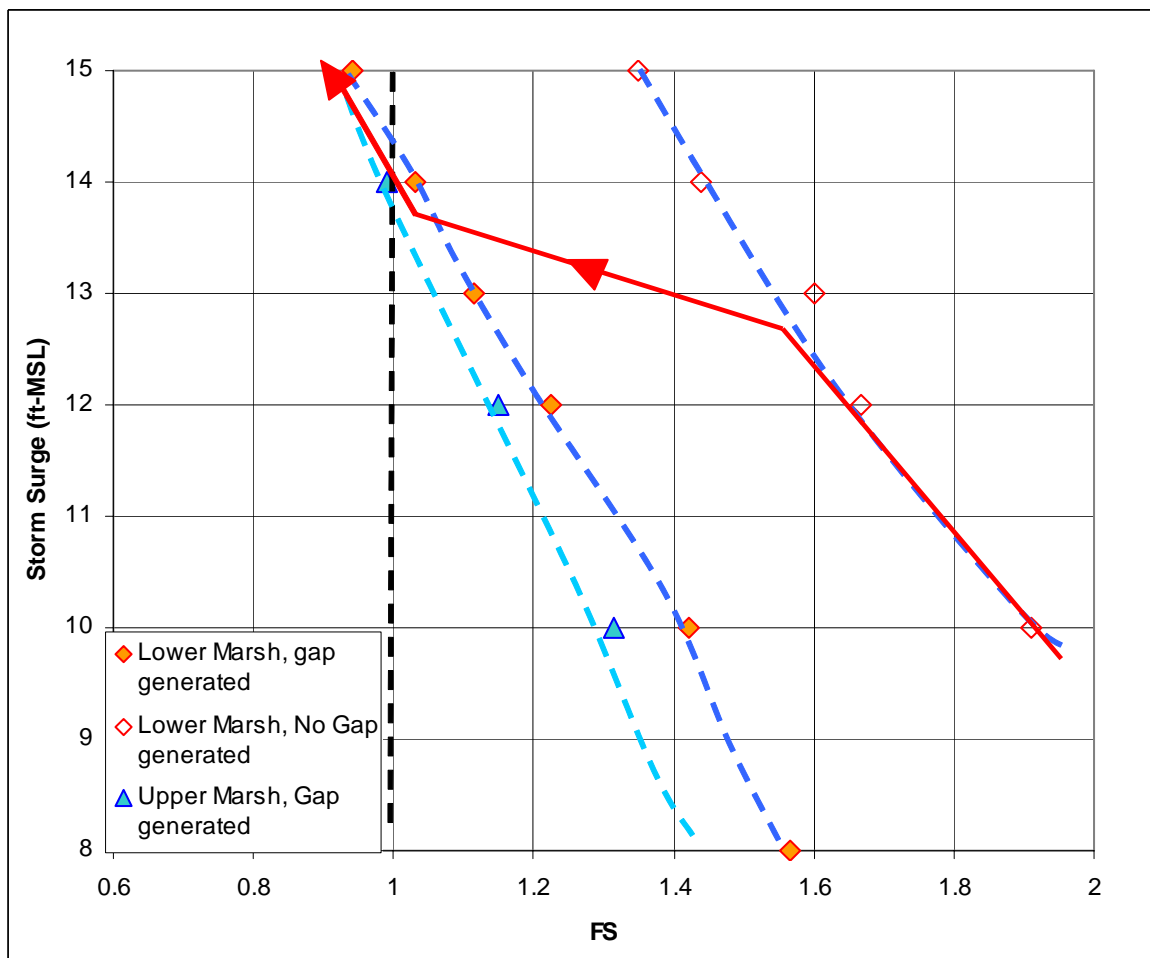
Figure 6.44: Calculated Factors of Safety for three modes based on SLOPE/W analyses of the Lower Ninth Ward South breach site (east bank IHNC) for various canal water elevations; showing the best-estimated path to failure.

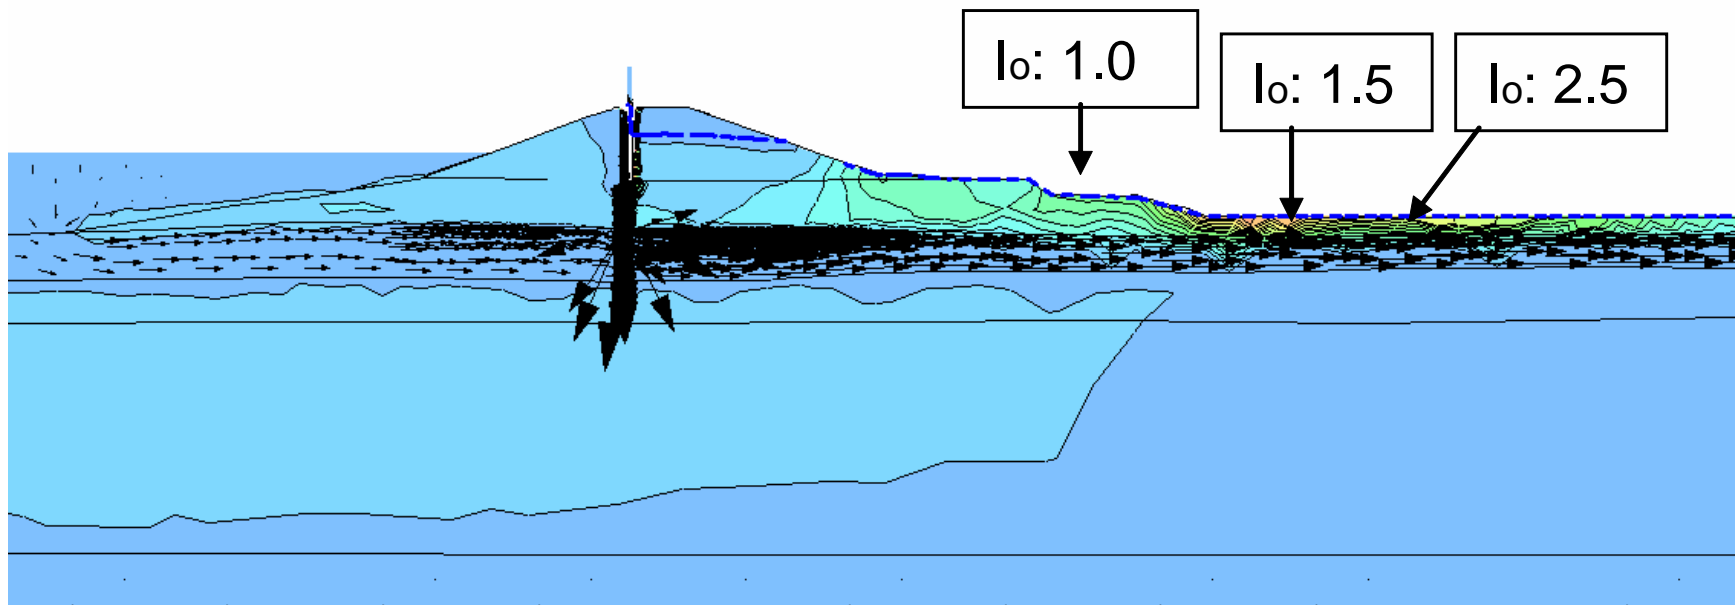
Figure 6.51: Hydraulic gradients for the north breach on IHNC. Storm surge at +14.4ft (MSL). Maximum exit gradient on the upper levee toe is $i_o \approx 1.0$, and $i_o \approx 1.5$ to 2.5 at the lower toe.

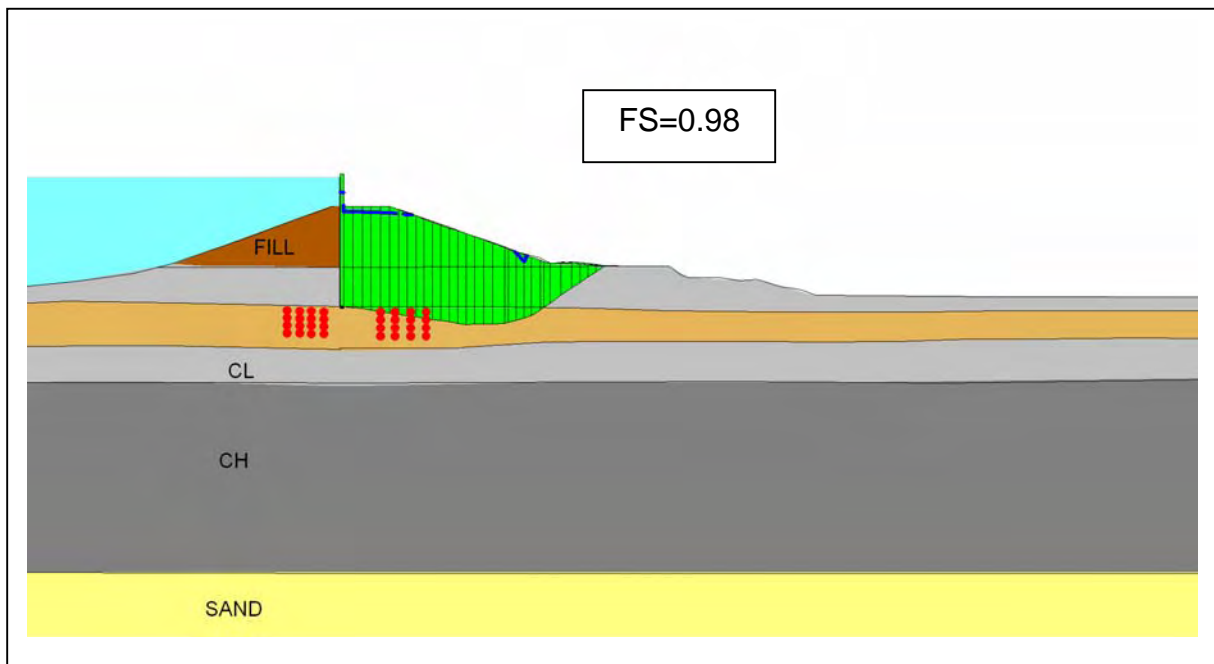
Figure 6.52: Critical potential stability failure surface for the north breach on IHNC. Storm surge at +14 ft (MSL).

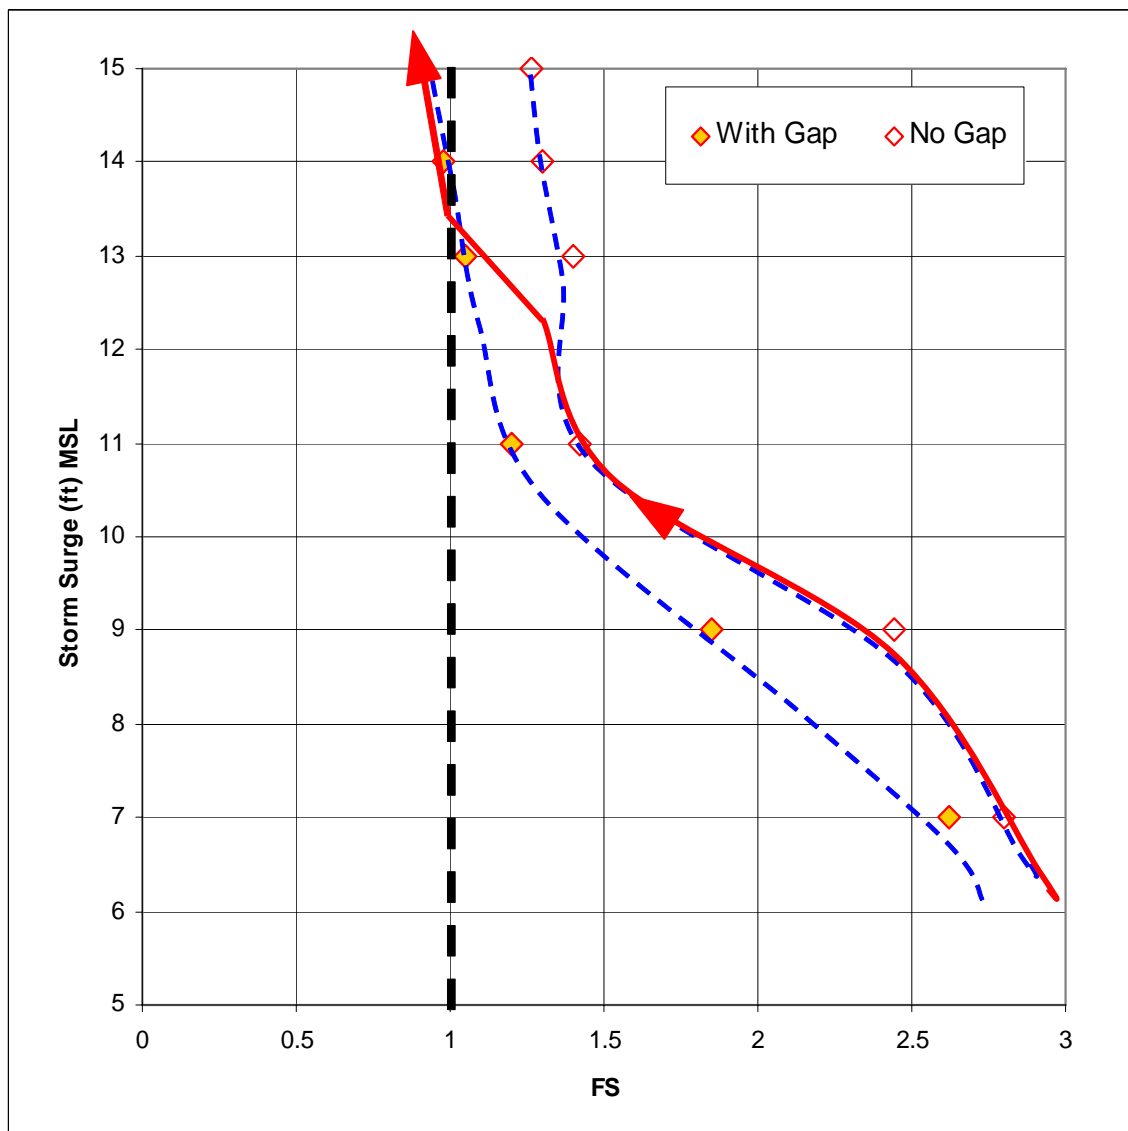
Figure 6.57: Factor of Safety vs. water elevation (ft, MSL) for the north breach, east bank of the IHNC at the west end of the Lower Ninth Ward.

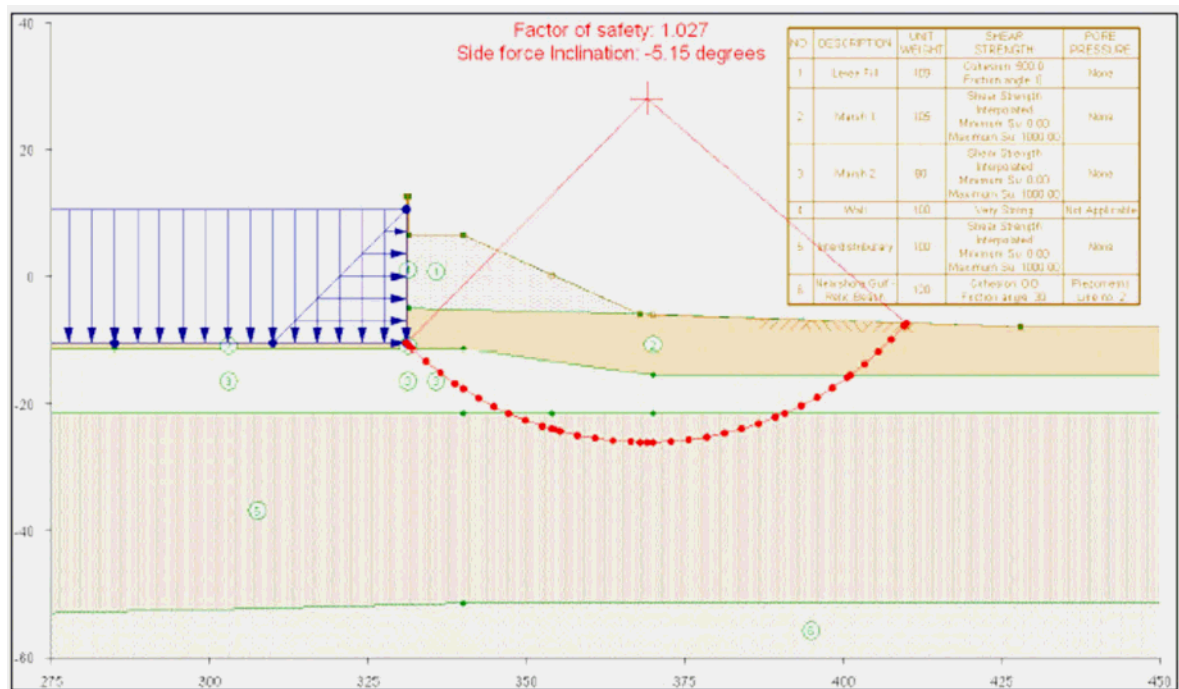
Repetition of the limit equilibrium analysis (Spencer's Method) of the failure surface shown in Figure 6.58, but using our own (ILIT) interpretation of undrained shear strengths within the critical lower clay layer (Figure 6.60) results in a calculated factor of safety, even conservatively assuming the presence of a water-filled gap on the outboard side of the sheetpile curtain, of $FS = 1.89$. This underestimates the actual overall Factor of Safety, which should actually be on the order of 10% to 15% higher based on three-dimensional considerations for this narrow, deep failure. It is therefore not likely that a deep, semi-rotational failure occurred, early on and at a relatively low canal water level, at this site.

Figure 6.59: Critical limit equilibrium stability failure mode from IPET Draft Final Report;
canal water elevation at +9 feet (MSL). Factor of Safety: 1.03.

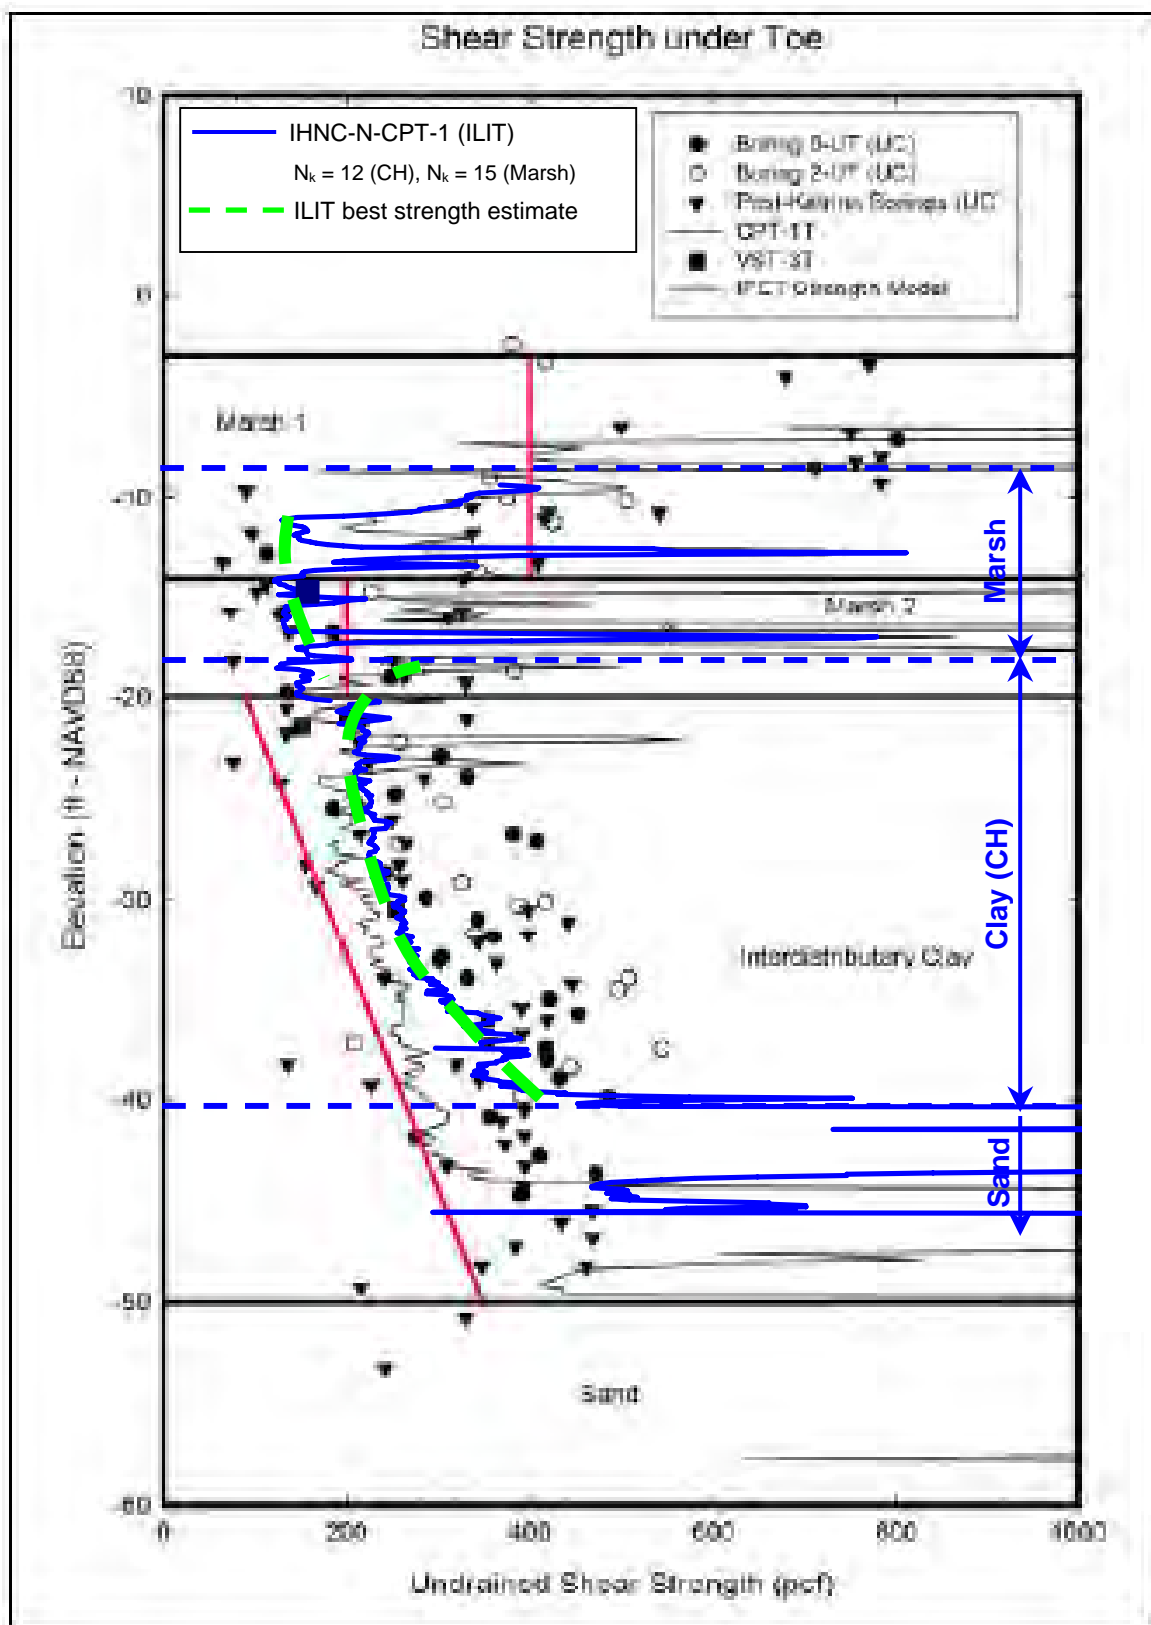
Our own studies determined (based on B_q values from the CPTU) indicated that values of $N_{kt} = 12$ were more appropriate for this lower soft clay (CH) layer, and the resulting re-interpretation of this CPT data based on $N_{kt} = 12$ is shown (with a dark blue trace) superposed over the previous Figure 6.59 in Figure 6.60. Similarly, the dark blue lines in Figure 6.60 show our (ILIT) interpretation of the layering at this location, and the light blue dashed lines show our interpretations of shear strength vs. depth at this section. The IPET shear strength interpretation, in addition to being low, was also based on the assumption that this lower clay stratum was normally consolidated over its full depth. As shown previously in Figures 6.25 and 6.26, our own interpretations showed several clear desiccation-induced overconsolidation profiles near the middle and top of this clay layer, and additional moderate overconsolidation near the base (likely to the base being well-drained and thus partially overconsolidated due to secondary compression), and these are reflected in our ILIT shear strength profile. In this figure, the CPTU-based shear strengths (based on $N_{kt} = 12$) can be seen to be in better agreement with the other shear strength data, and the overall shear strength vs. depth profile is more consistent with this data.

Figure 6.60: Re-interpretation of shear strength, and the ILIT shear strength profile.

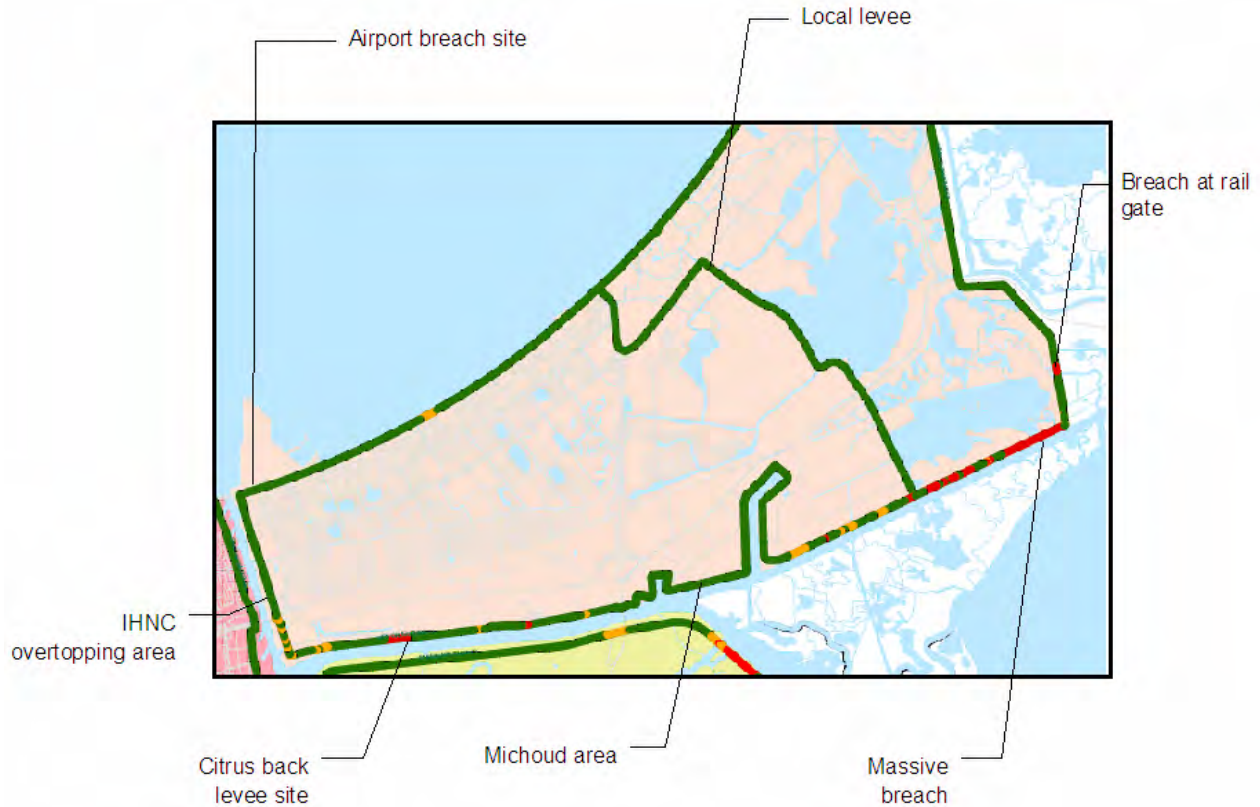
Figures 7.1 and 7.2 show the locations of damage to the levee system surrounding the New Orleans East (NOE) protected area. The most significant damage to the system occurred to East Back Levee that fronts the GIWW and Lake Borgne. Here the storm surge completely destroyed (and massively eroded) large expanses of earthen levee in the southeastern corner of the NOE protected area. Additional smaller, but nevertheless significant breaches also occurred along other portions of these NOE back levee reaches. As the storm surge next passed west two significant levee breaches occurred, both due to overtopping, along the north bank of the east-west trending channel of the GIWW/MRGO. Damage (mostly in the form of scour) also occurred along the IHNC East Levee and portions of the New Orleans Lakefront Levee located near the Lakefront Airport as the storm surge raised the water levels within the IHNC. Finally, the reverse (counterclockwise) swirl of the storm winds raised the levels along the south shore of Lake Pontchartrain. Portions of the levee system fronting Lake Pontchartrain, such as the New Orleans Lakefront, Citrus Lakefront, and New Orleans East Lakefront Levees, generally performed well in the hurricane, as did most of the New Orleans East Levee located to the east.

Figure 7.2: Damage locations in the NOE protected area (base map from USACE.) Color indicates severity of damage, with red being the worst. [IPET; March 10, 2006]

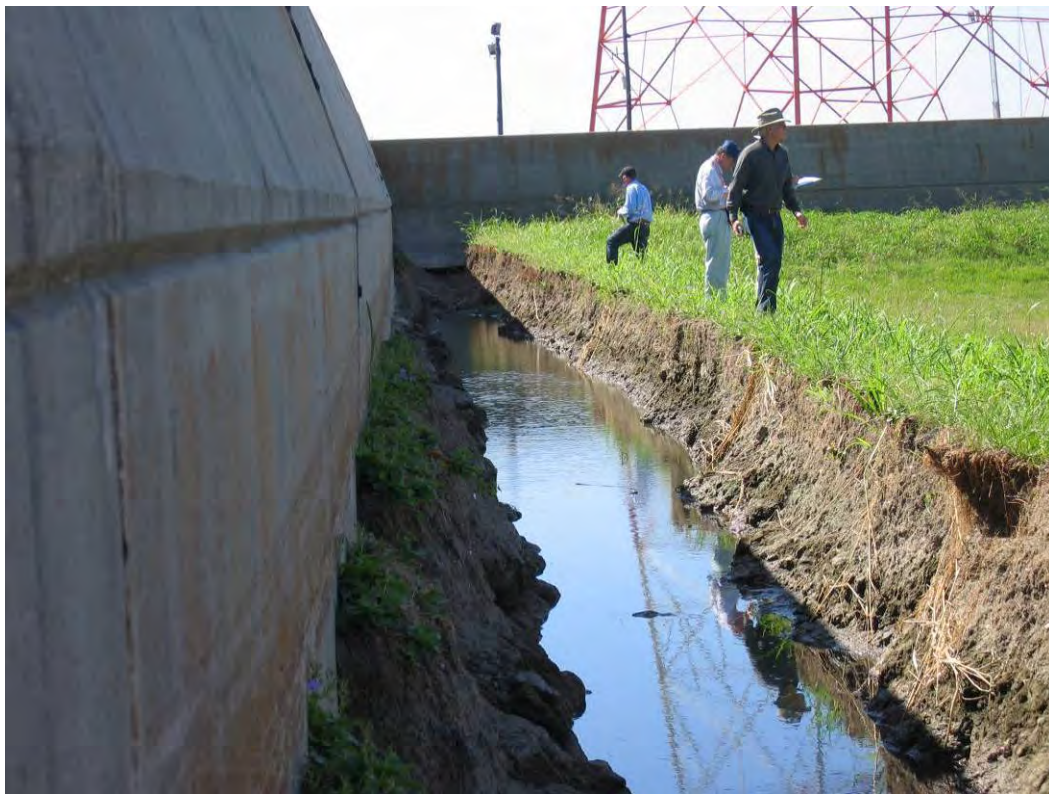
Figure 7.10: Deflected and tilted sheet pile sections near Pump Station 15.

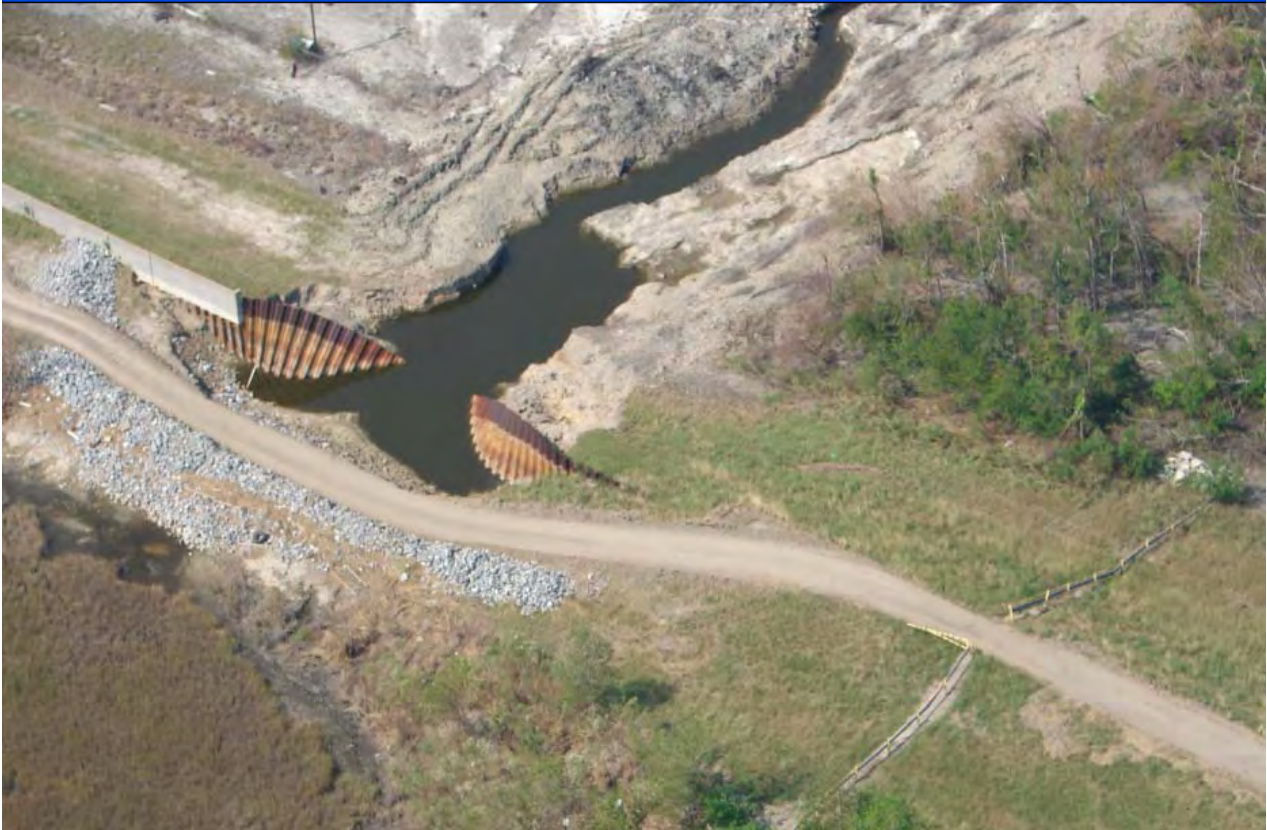
Figure 7.11: Scour at the base of floodwalls near the Michoud Canal.

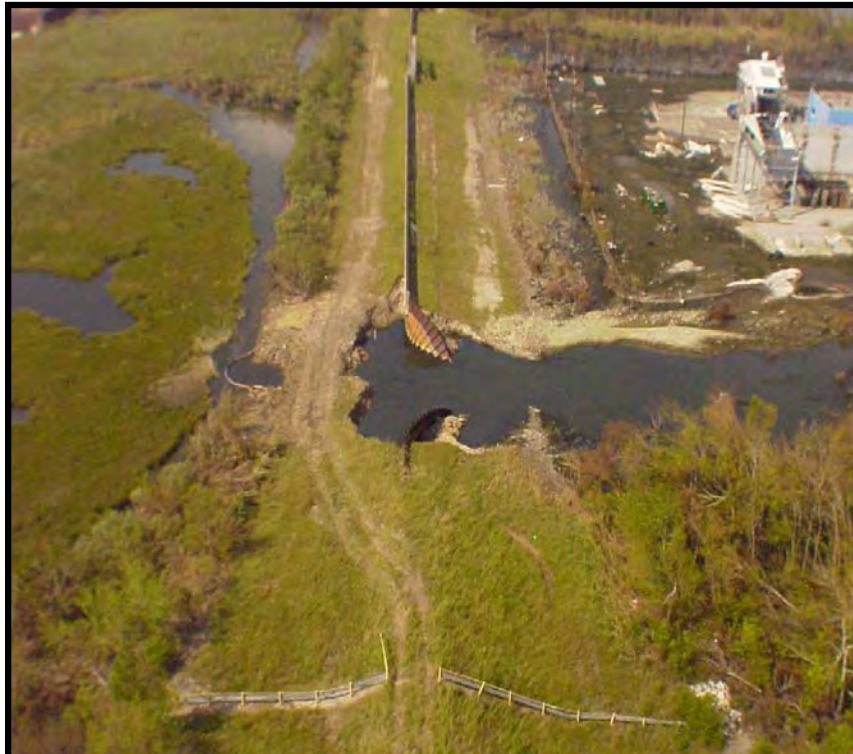
Figure 7.12: Failed sheetpile transition at the Air Products Corporation site; NOE back levee.

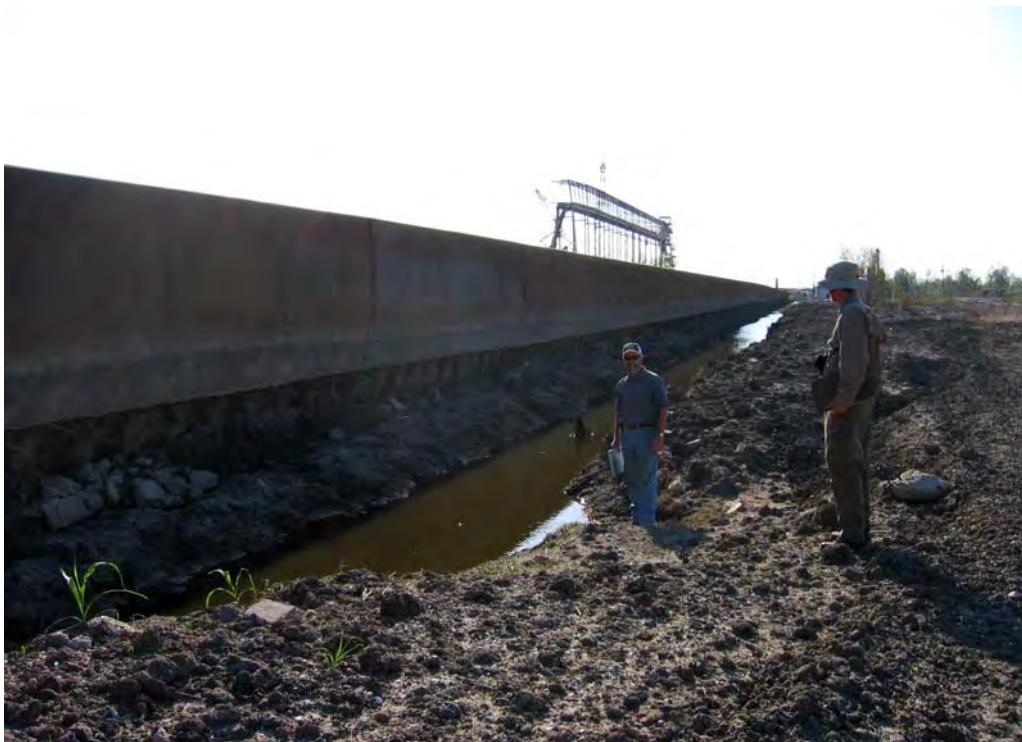
Figure 7.13: Second view of failed sheetpile transition.
